ERDC/CHL TR-04-8

Toussaint River, Ohio, Ordnance Migration Study

August 2004

Final report

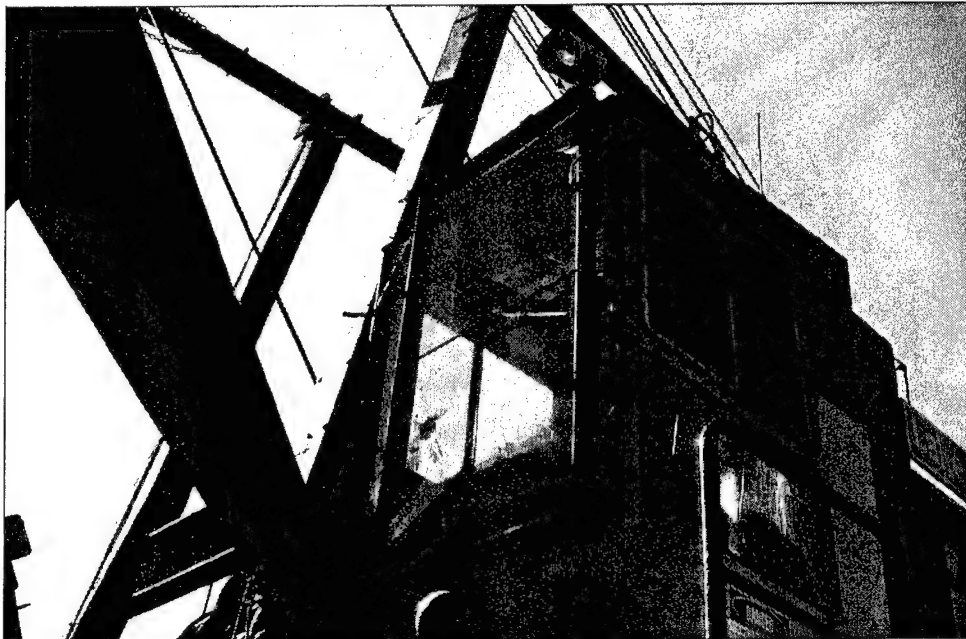
Figure 7. Crane operator's protective barrier

The contract specifications required that the crane operator be protected by protective barriers possessing structural properties equivalent to 1.0-in.-thick steel plate protection barrier (as compared to the 0.25-in.-thick plate required in 1995)(Figure 7), as well as the crew on the spud barge (Figure 8) and the scow release operator. The scow operator was to be protected during dumping operations, from any potential exploding ordnance. The protection provided was similar to the crane operator's protection and was located at the scow release-mechanism station (Figure 9). A "Safety Zone" of 1,250 ft between the disposal scow and any other vessel was in effect during disposal operations. No personnel were allowed on the scow during transport operations, and once over the disposal area, a single workman was transported to the scow to accomplish the unloading procedure. That workman was required to be behind the protection equipment prior to opening any of the scow doors.

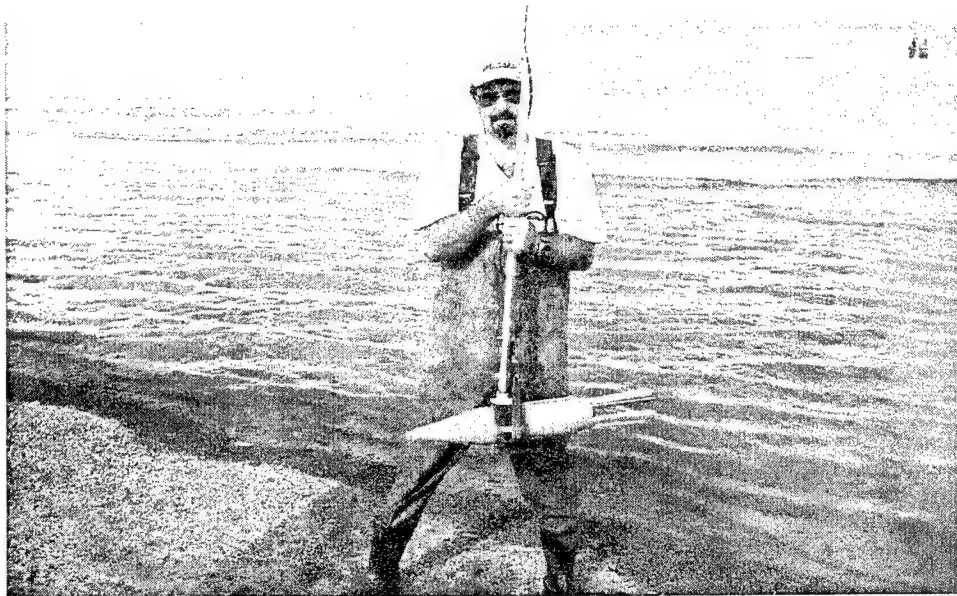
Figure 18. SO deployment device. Note the gentle bathymetry slope of study site illustrated by depth of water that the two people in upper right-hand corner are standing in and the waves shoaling on the first sand bar offshore

SO was placed on the lake bed using an SO deployment device (Figure 18). The device was needed to assure that the desired deployment orientation of the SO could be achieved, and to establish a deployment location when visibility was

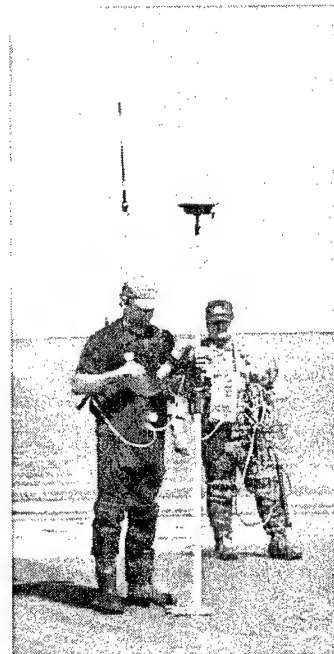
Figure 19. The Trimble Model 4700 RTK Rover positioning 60-mm SO

The procedure used during the surveys was to use the RTK rover to return to the last surveyed position of each piece of SO and visually attempt to relocate it or tap on it with the survey rod; this worked well with SO that did not experience significant movement). If the SO was not found using this method, (depending on which SO was being located) either the acoustic or radio tracking system was used to approximately locate the SO, then its precise position was determined with the RTK DGPS. An underwater video camera system was brought along on each survey. The portable drop-camera (with optional underwater lights), mounted on a pole and coupled to a surface video screen, was used to locate the SO if lake visibility permitted. Due to poor water clarity, the system was frequently needed to make a visual inspection of the SO. Where possible, the camera was used to read a hand-held compass temporarily mounted on the SO, thereby determining its approximate orientation. SO orientation was defined by the bearing line measured from the SO base to the fuse, referenced to magnetic north. The survey rod tip was placed on top of the SO, as close to its body midsection as possible, to measure its position as accurately and precisely as could be practically accomplished.
